## User Safety Notice

Altair® 5X PID

August, 2023

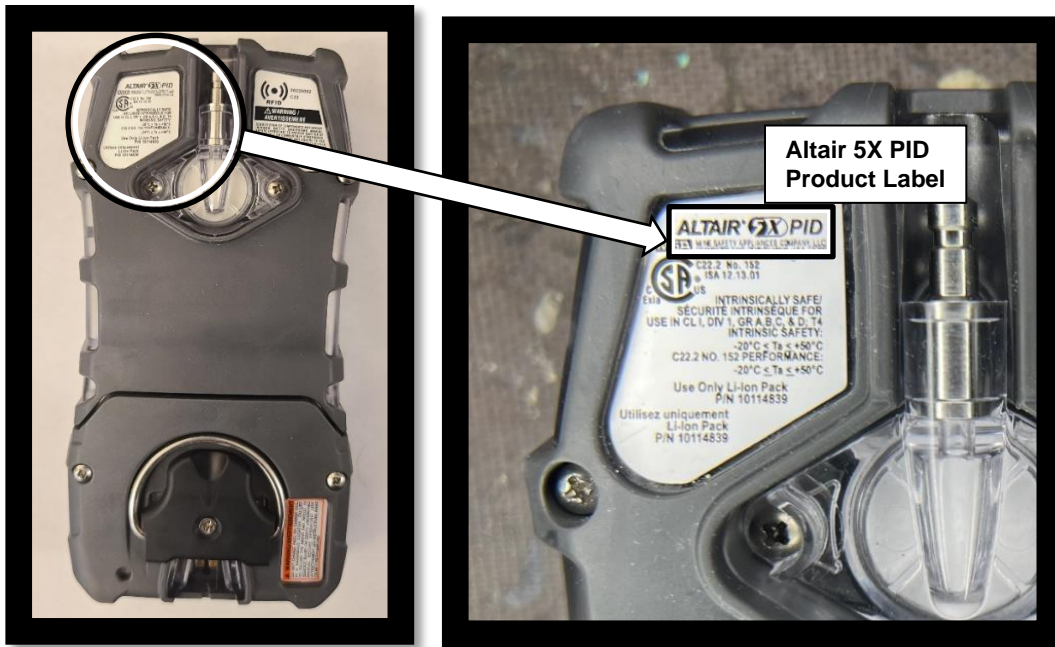
**Figure 1 – Altair 5X PID Product Label**

1. Reference the product label found on the back of the housing (Figure 1)
  - a. If the label states Altair 5X PID, proceed to step 2
  - b. If the label does not state Altair 5X PID, the product is not affected, and no action is needed.

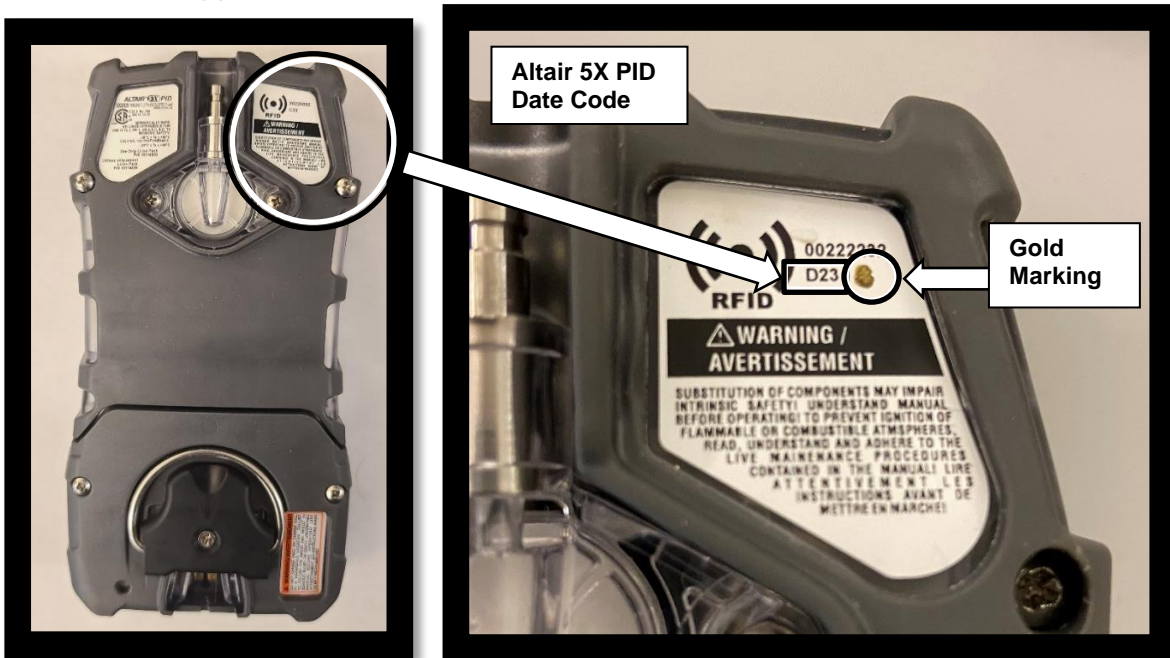
**Figure 2 – Altair 5X PID Date Code Identification**

2. To find the date code for the Altair 5X PID, reference the date code on the back of the unit. (Figure 2)

1st digit indicates month of manufacture (A = January, B = February, etc.).  
2nd and 3rd digits indicate year of manufacture (22 = 2022, 23 = 2023, etc.).

- a. If your Altair device has a gold marking as shown in Figure 2, the product is not affected, and no action is needed.
- b. If the Altair device was manufactured from March 2020 to and including June 2023, your PID sensor is affected.
  - i. Follow the updated guidance outlined in this notice.
- c. If the Altair device was manufactured prior to March 2020 or after June 2023, proceed to step 3.

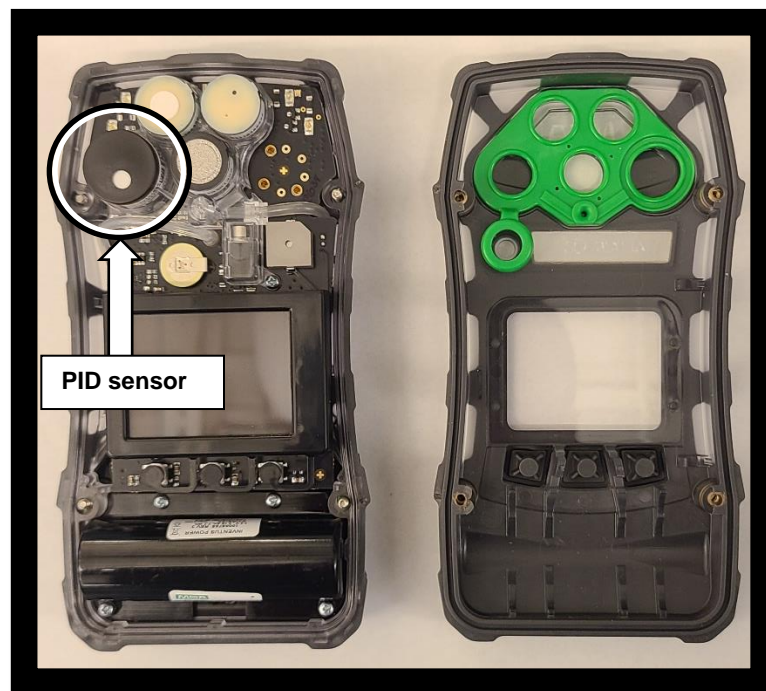
**Figure 3 – Accessing the PID Sensor**

Remove the PID Sensor (Figure 3) per section 6.4 (Maintenance Procedure – Replacing or Adding a Sensor) of the Altair 5X PID Instruction Manual.

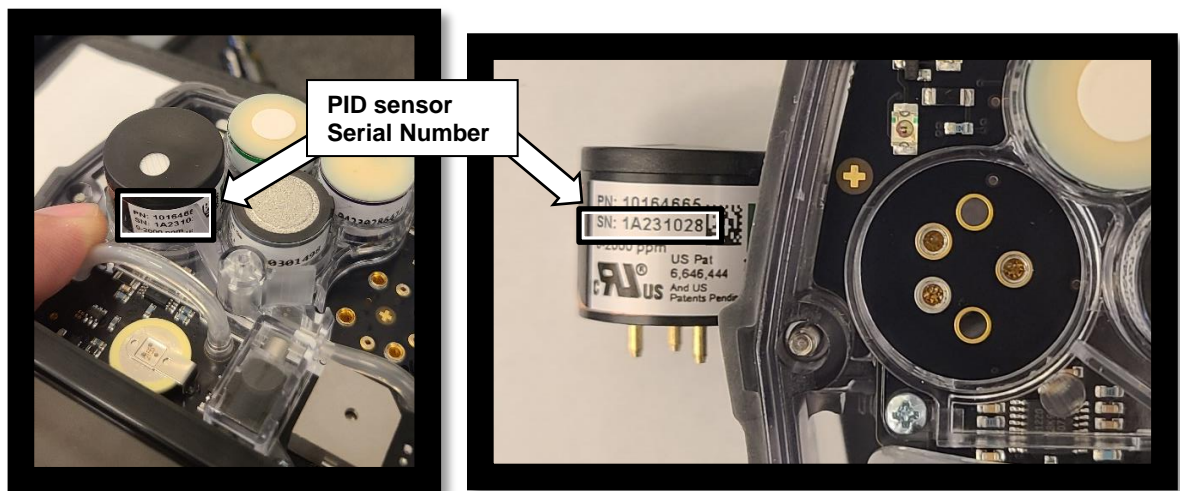
**Figure 4: PID Sensor Serial Number Identification**

4. To find the date code for the PID sensor, reference the 2<sup>nd</sup>, 3<sup>rd</sup>, and 4<sup>th</sup> digits of the serial number of the PID sensor on the side of the sensor. (Figure 4)

2<sup>nd</sup> digit indicates month of manufacture (A = January, B = February, etc.).

3<sup>rd</sup> and 4<sup>th</sup> digits indicate year of manufacture (22 = 2022, 23 = 2023, etc.).

- d. If the sensor was manufactured prior to March 2020, your PID sensor is not affected.
  - i. No procedural changes are needed.
- e. If the sensor was manufactured during March 2020 to and including June 2023, your PID sensor is affected.
  - i. Follow the updated bump test guidance outlined in this notice.

5. Re-install the PID sensor and battery per section 6.4 (Maintenance Procedure – Replacing or Adding a Sensor) of the Altair 5X PID Instruction Manual.
6. Perform bump tests or manual gas checks on all affected units each time the Altair 5X PID device is turned on, prior to use.
