User Inspection Advisory

UEBSS Fitting

February 2025

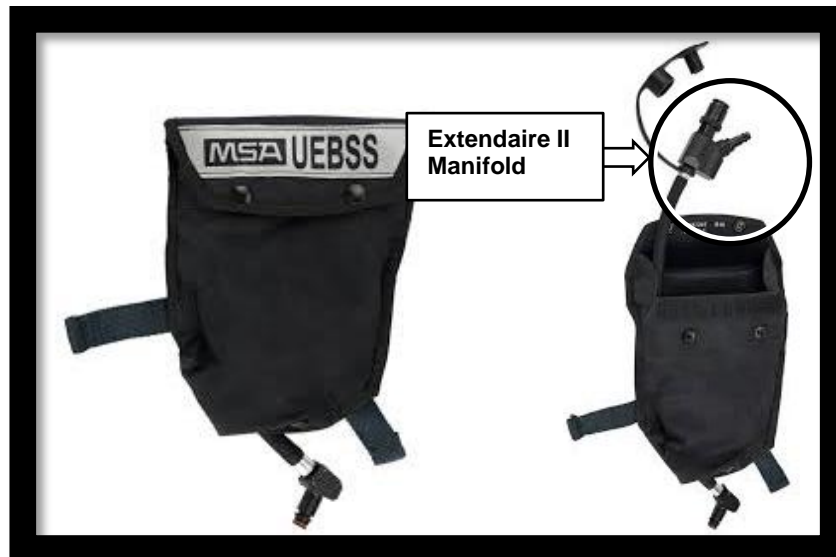
Figure 2: UEBSS Pouch

- a. If your device is **equipped with a pouch with the lettering “UEBSS”** (Figure 2) → Your device is affected and must be inspected per this notice.
- b. You may also **locate the Part Number inscribed on the Extendaire II manifold** (Figure 3)
 - i. PN: 10186989 → Your device is affected and must be inspected per this notice.
